UNITED STATES ARMY AVIATION
CRASH INJURY RESEARCH

Final Report

TRECOM Technical Report 63-23

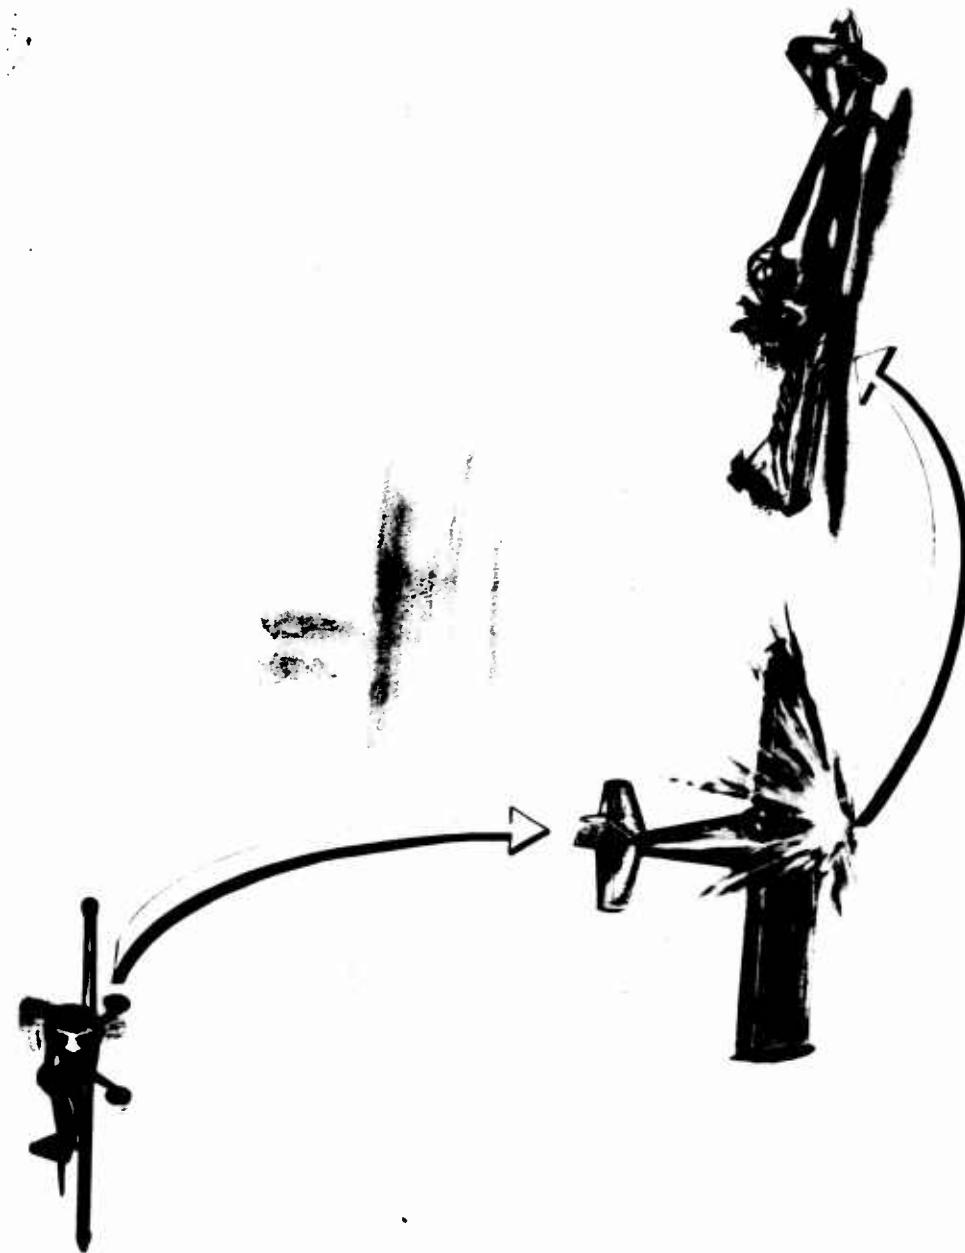
Figure 2. Kinematics of the Snow S-2B Accident, Phoenix, Arizona.

Investigation revealed that the crash protection features incorporated into the aircraft were instrumental in crash force attenuation to the cockpit section and damage reduction to the cockpit environment. The moderate injuries sustained by the pilot were directly related to improper use of the shoulder harness. It was further revealed that the location of the shoulder harness is of special significance relative to occupant retention.

1. The shoulder harness anchorage be located immediately above the seat back and attached to the roll-bar structure;
2. Inertia reels be incorporated in the restraint system employed in this aircraft; and
3. Consideration be given to the value and utilization of crash protection design, as illustrated in this report, in future Army fixed-wing aircraft which will be utilized in nap-of-the-earth operations.

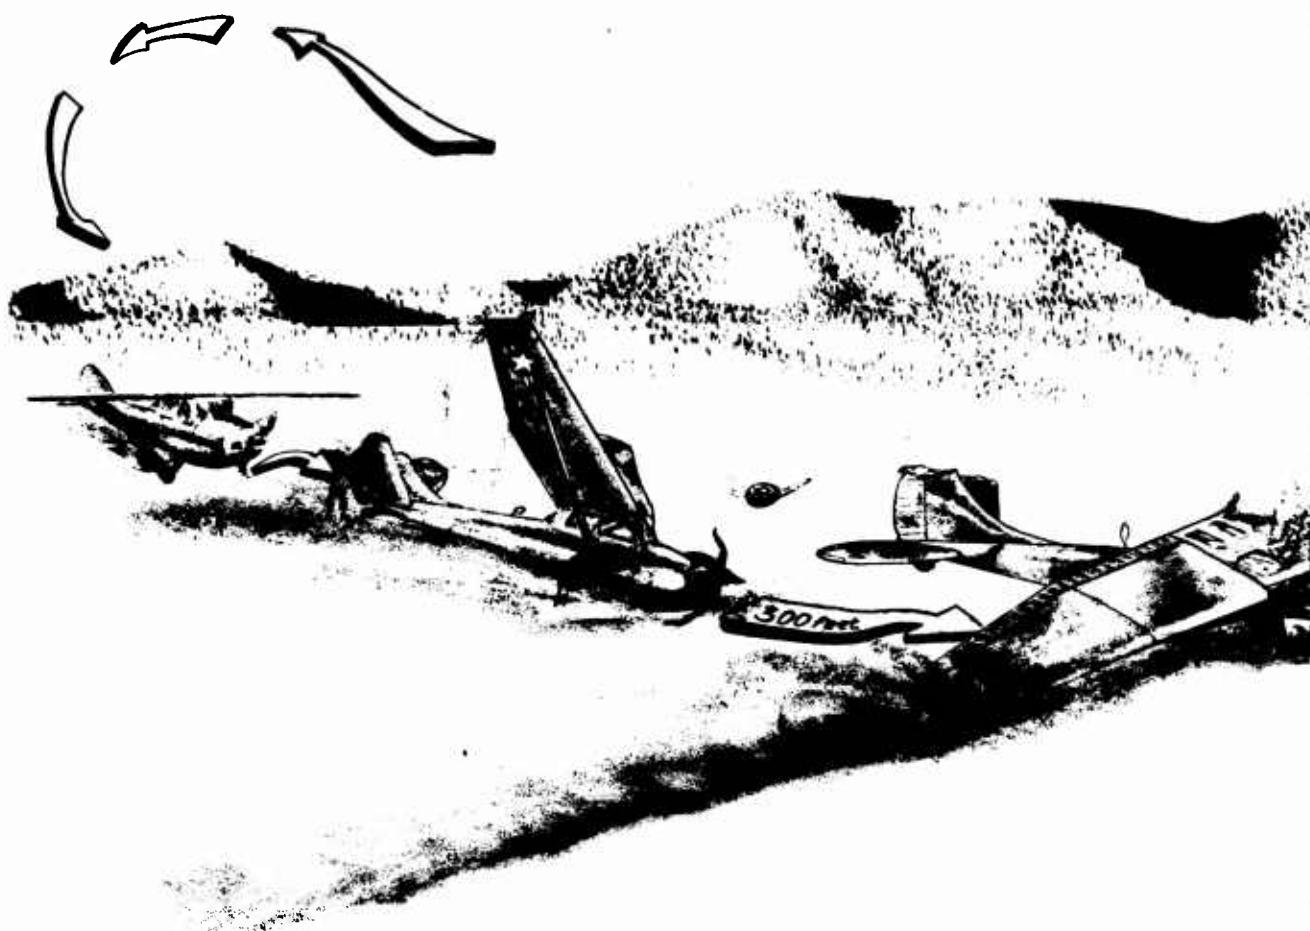
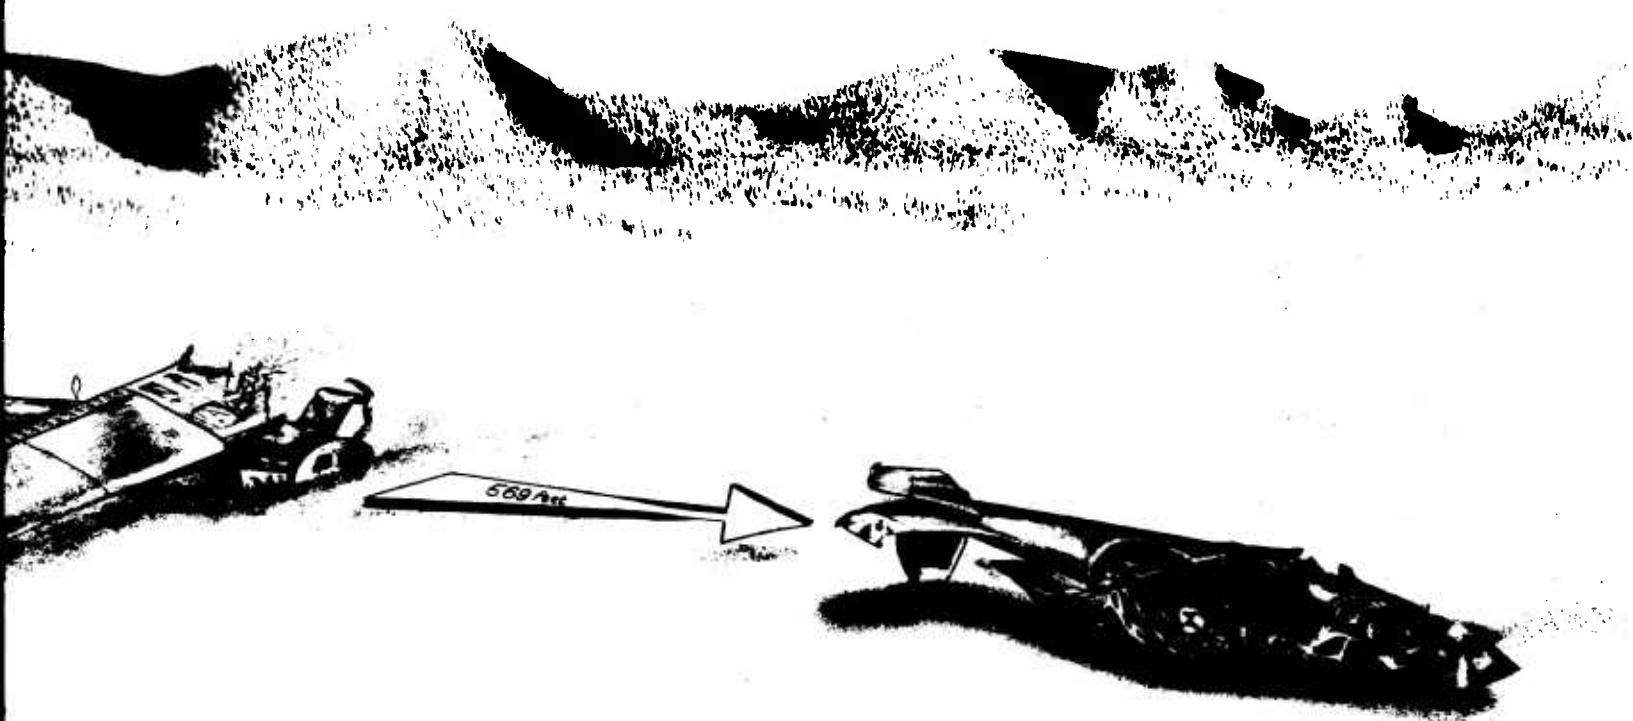
Figure 4. Kinematics of the L-19E Accident, 1

Investigation revealed extensive damage to the entire aircraft and inward collapse of the occupiable area. The pilot sustained compression fractures of the vertebrae and lacerations of the face. The passenger received only a minor head laceration.

It is believed that the attachment of the restraint system to primary structure prevented more serious injuries to the occupants than could be expected in accidents with damage incurred of this magnitude.

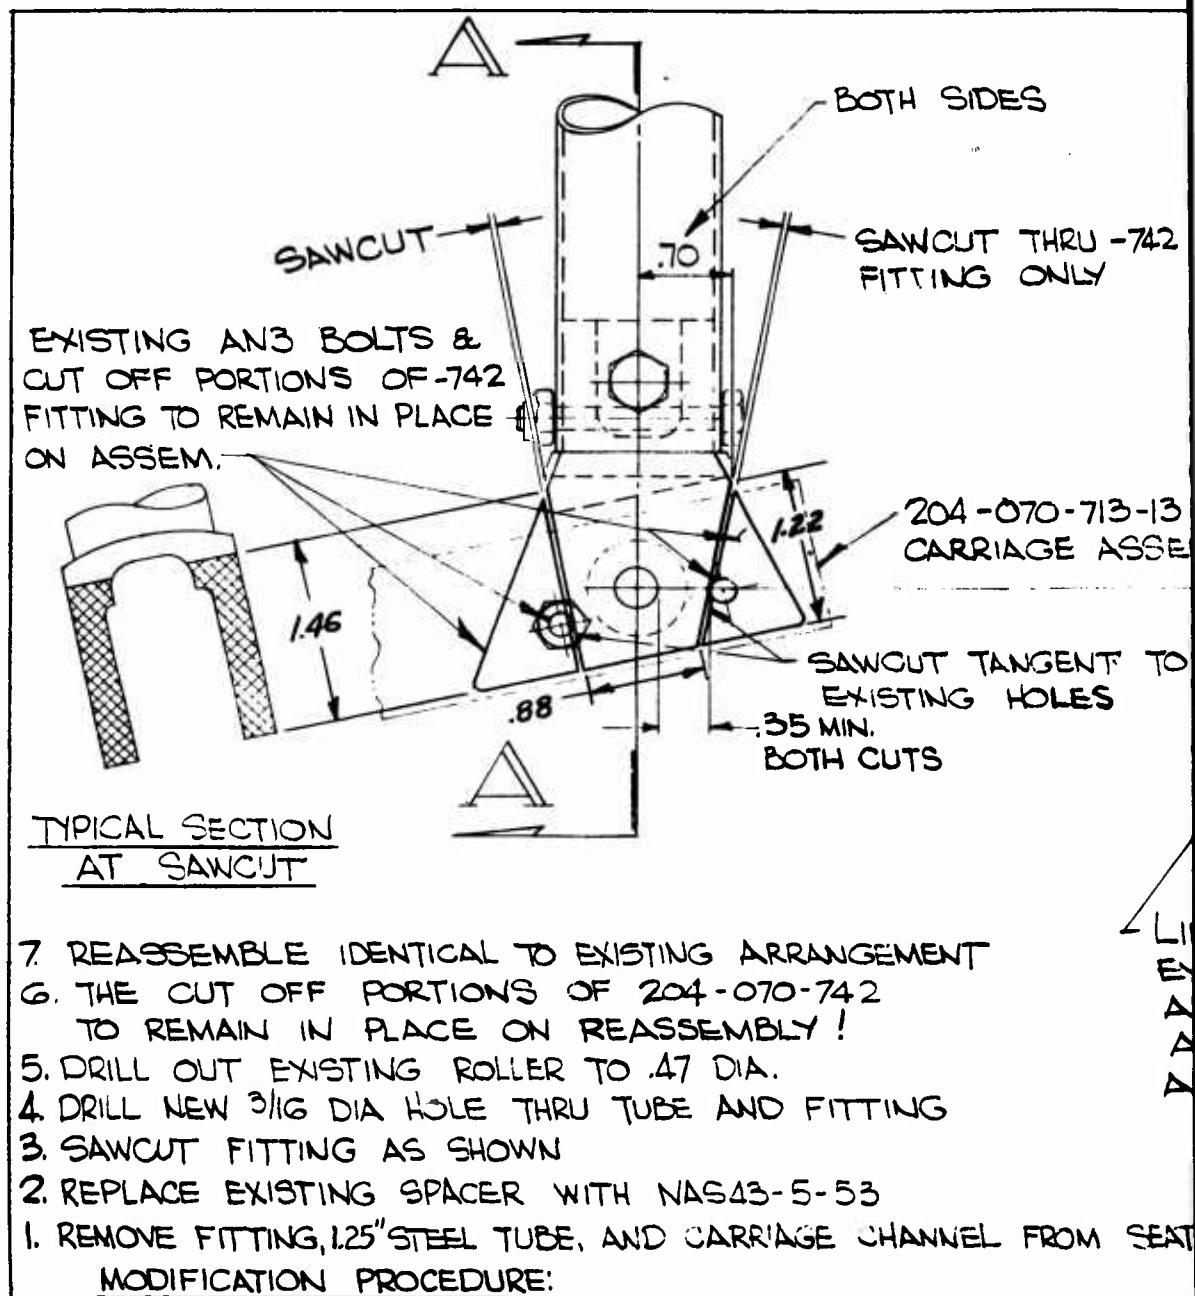
Figure 7. Interim Fix of the Seat Belt Tiedown in the HU-1 Aircraft.

Figure 7 depicts the interim fixes recommended in the report.

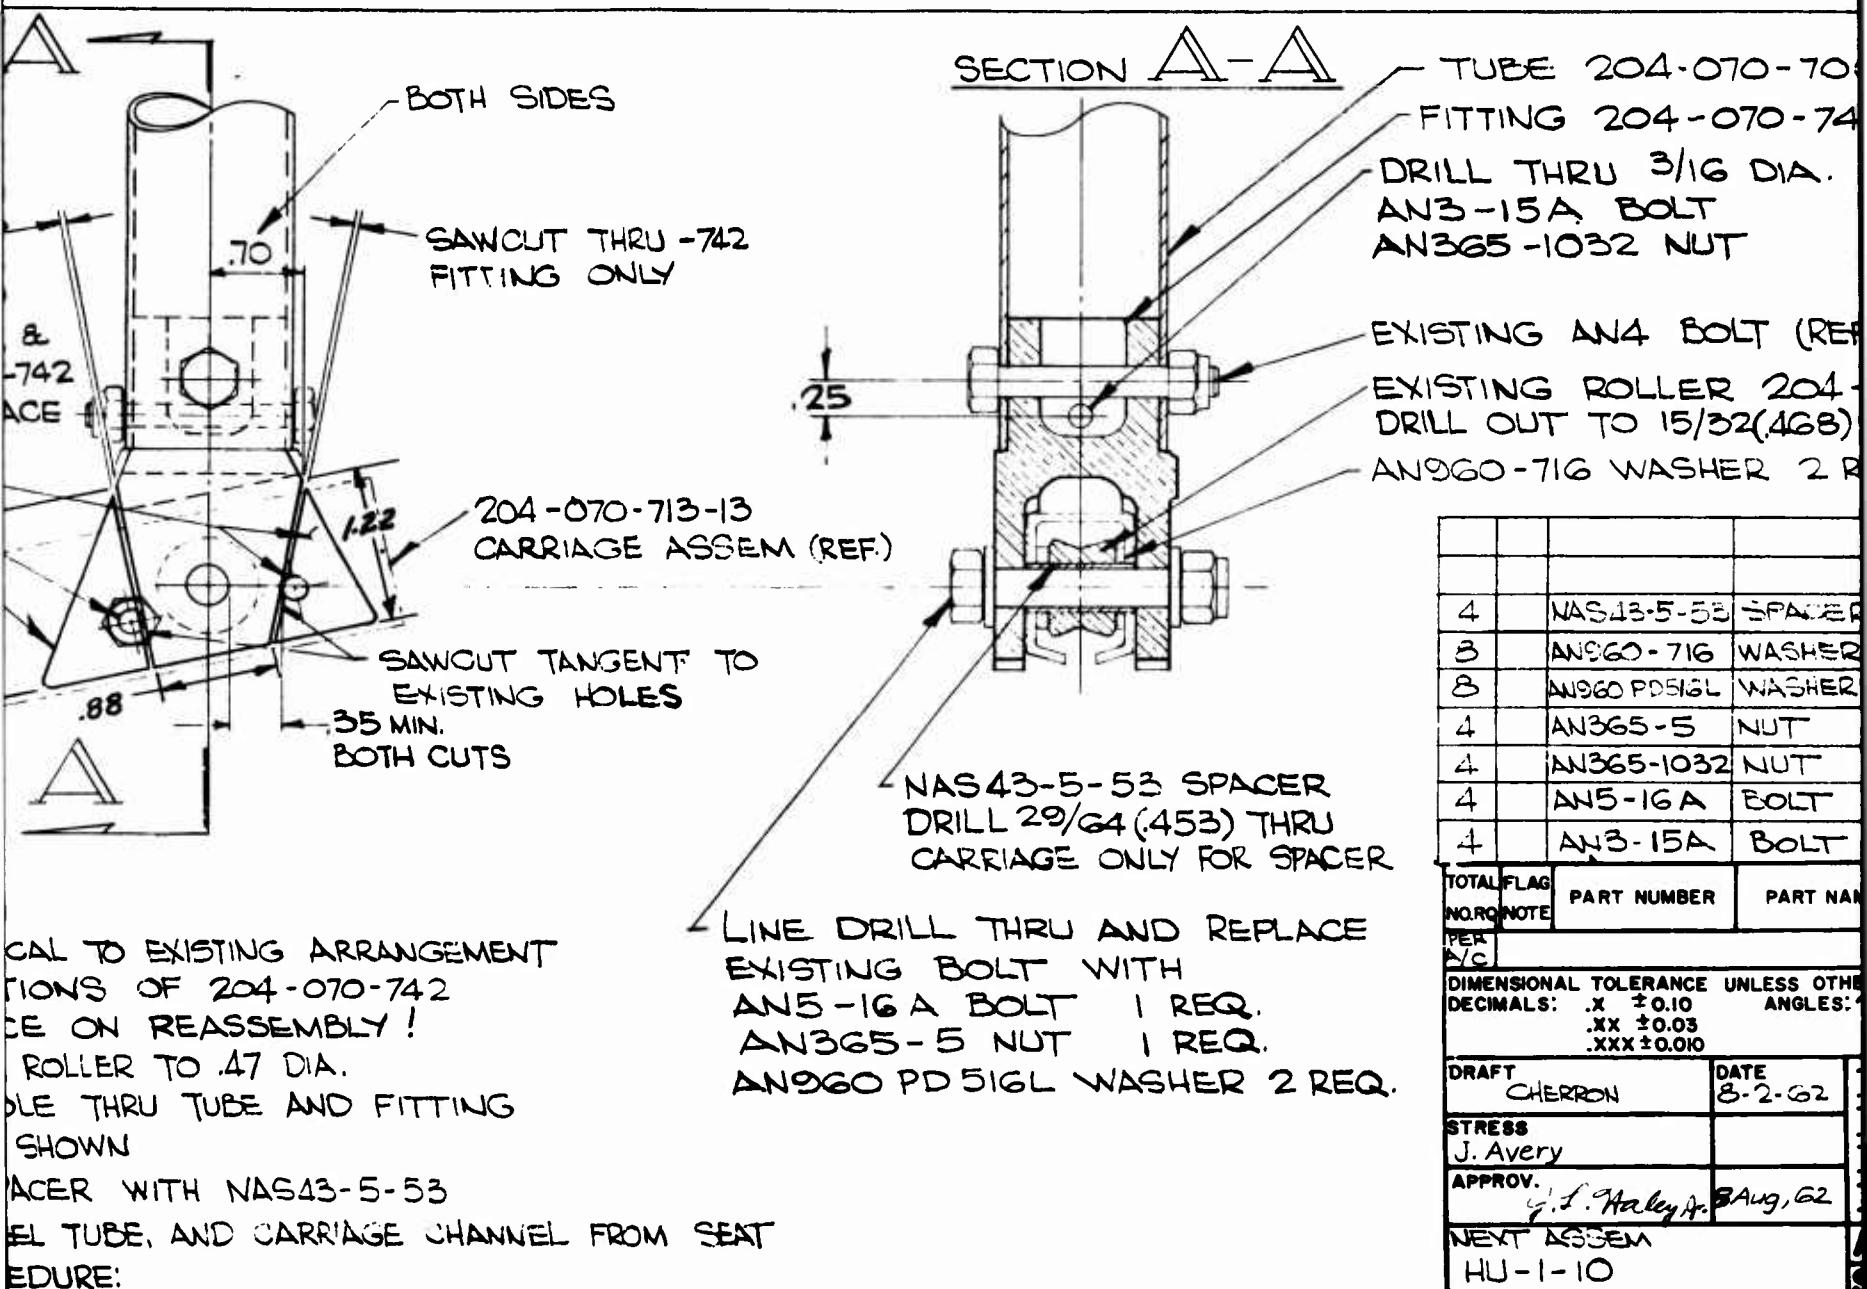
Figure 6. Modification Aft Carriage Attachment, Crew Seat.

The crew seat of the HU-1A aircraft has failed frequently in survivable-type accidents, with the primary failure occurring in the carriage attachment fitting (part number 204-070-742-1). The most recent accident investigated by this agency occurred at Fort Carson, Colorado, 7 May 1962 (reference Item 1, TCREC Technical Report 62-87). Analysis disclosed that occupant inertia load of the order of 11G could have caused these failures.

On the basis of accident evidence and a detailed stress analysis of the existing attachment fitting, it was concluded that the fitting is excessively stressed due to the moment fixity of its connection to the carriage channel. Consequently, it presents a weak link in the tiedown chain (seat belt, seat belt anchorage, shoulder harness and anchorage, seat structure, seat anchorages, and floor). Based upon the disclosures of the analysis, it was recommended that the proposed field modification (Figure 6) be incorporated on all HU-1A and HU-1B aircraft.

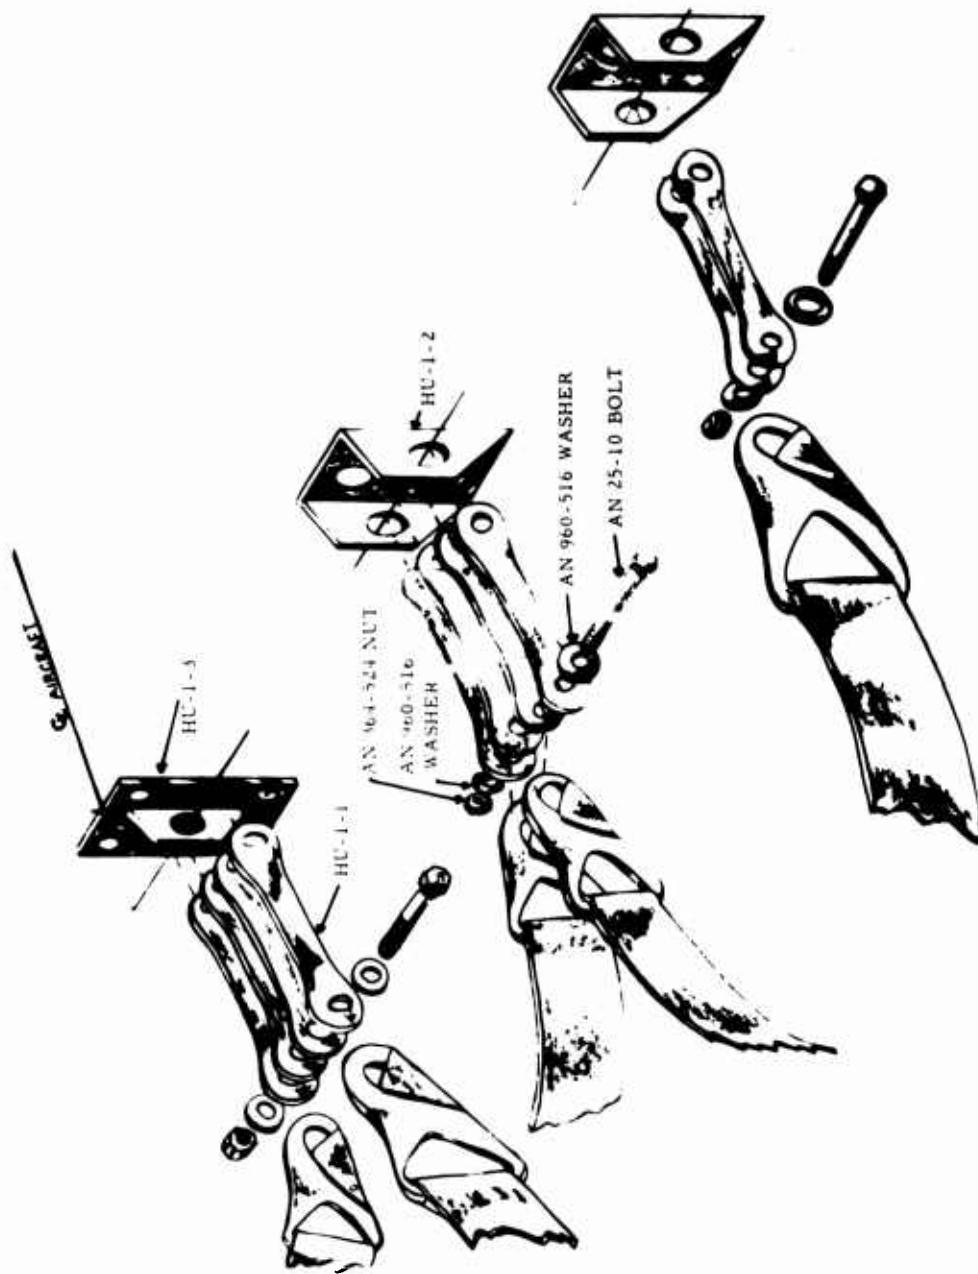
Analysis of several HU-1 helicopter accidents disclosed a definite weakness in the occupant tiedown system. This deficiency has contributed, either directly or indirectly, to the injury of personnel involved in these accidents.

This report proposed both an interim fix and a permanent solution to the problem of troop seat safety belt anchorage failures in the HU-1 series aircraft. A quick "off the shelf" interim fix to make the existing tiedown system four times more effective and a permanent fix that would ensure that the strength of the tiedown was equal to the seat belt strength was proposed.

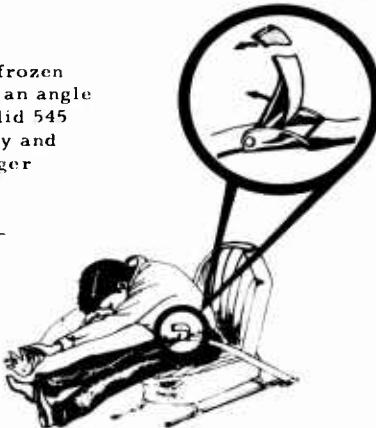
Figure 8. AvCIR Design for Safety Memo No. 62-1.

A light personal plane stalled out during a turn and struck the ground at an estimated speed of 60 mph and a 30 degree angle of impact. The pilot suffered a depressed skull fracture (fatal) when his head struck environmental structure. The cockpit area remained relatively intact and the impact conditions can, therefore, be considered survivable.

Seat belt and shoulder harness were anchored to the pilot's seat. Consequently, all inertia loads resulting from the crash deceleration were transmitted to the seat-floor anchorages. The two aft legs failed and the seat hinged forward, allowing the pilot to come into forcible contact with structure ahead.

To reduce the stress on the seat, RESTRAINT SYSTEMS SHOULD BE ANCHORED TO BASIC AIRCRAFT STRUCTURE. If this is not practicable, the seat structure itself and its anchorages should be designed to withstand the ultimate dynamic loads, compatible with survivable impact conditions.

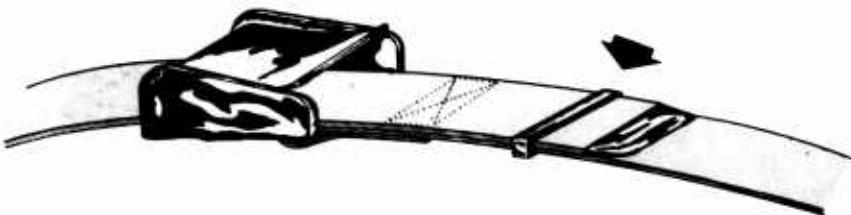
Figure 9. AvCIR Design for Safety Memo No. 62-2.

A light aircraft crashed on a snow-covered, frozen lake at a speed of approximately 110 mph, at an angle of approximately 15 degrees. The aircraft slid 545 feet. The pilot's seat belt functioned properly and he survived with minor injuries. His passenger was thrown clear of the aircraft and suffered fatal head injuries. There were no gross failures of the passenger's seat belt and cam-type buckle. Several serration marks in the belt webbing were indicative, however, of intermittent slippage of the buckle. It is assumed that this progression of hold and slip resulted eventually in complete loss of restraint for the passenger.

It has been shown, experimentally, that inertia loads acting on the "free end" of the seat belt webbing may contribute to buckle slippage by lifting the lip of the buckle. Depending on the nature and the sequence of the crash pulses, this slippage may be complete or partial. In the latter case, part of the webbing may pass through the buckle before it finally locks, thereby imparting heavy jolt loads on the occupant, as well as the entire restraint system.

One suggested method to avoid inadvertent buckle release due to inertia loads, acting on the unused portion of the webbing, is the incorporation of a belt loop through which the "surplus" webbing of the seat belt can be inserted and held down. The design of the loop should preclude interference with the normal release of the belt.

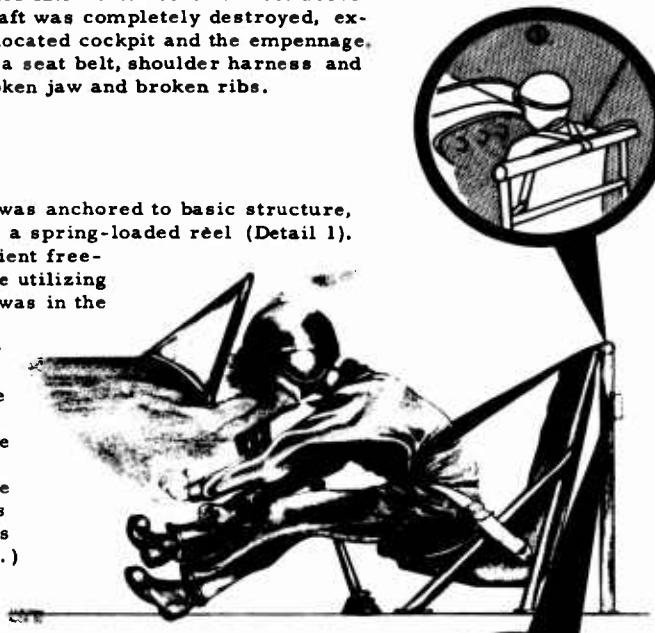
A late-model agricultural aircraft, incorporating several crash safety features, struck the ground in a vertical dive after propeller failure at about 200 feet above the ground. The aircraft was completely destroyed, except for the centrally located cockpit and the empennage. The pilot, protected by a seat belt, shoulder harness and helmet, suffered a broken jaw and broken ribs.

The shoulder harness was anchored to basic structure, but did not incorporate a spring-loaded reel (Detail 1). In order to have sufficient freedom of movement while utilizing the harness, the pilot was in the habit of wearing the shoulder straps under his arms. Consequently, his head struck the top of the instrument panel during the severe longitudinal deceleration, while the pressure of the shoulder straps caused fractures of his lower ribs. (See figure.)

The crash resistance of well-designed aircraft structure can be fully utilized only in conjunction with an adequately stressed and used restraint system (seat, seat belt and shoulder harness). To insure proper use of the shoulder harness, without interference with the pilot's movements in the cockpit, it is necessary, in most aircraft, to anchor the shoulder harness via a spring-loaded reel (Detail 2). By making this reel impact-sensitive, in addition to manual-locking provisions, the pilot's upper torso and head protection will be optimal under all crash conditions.

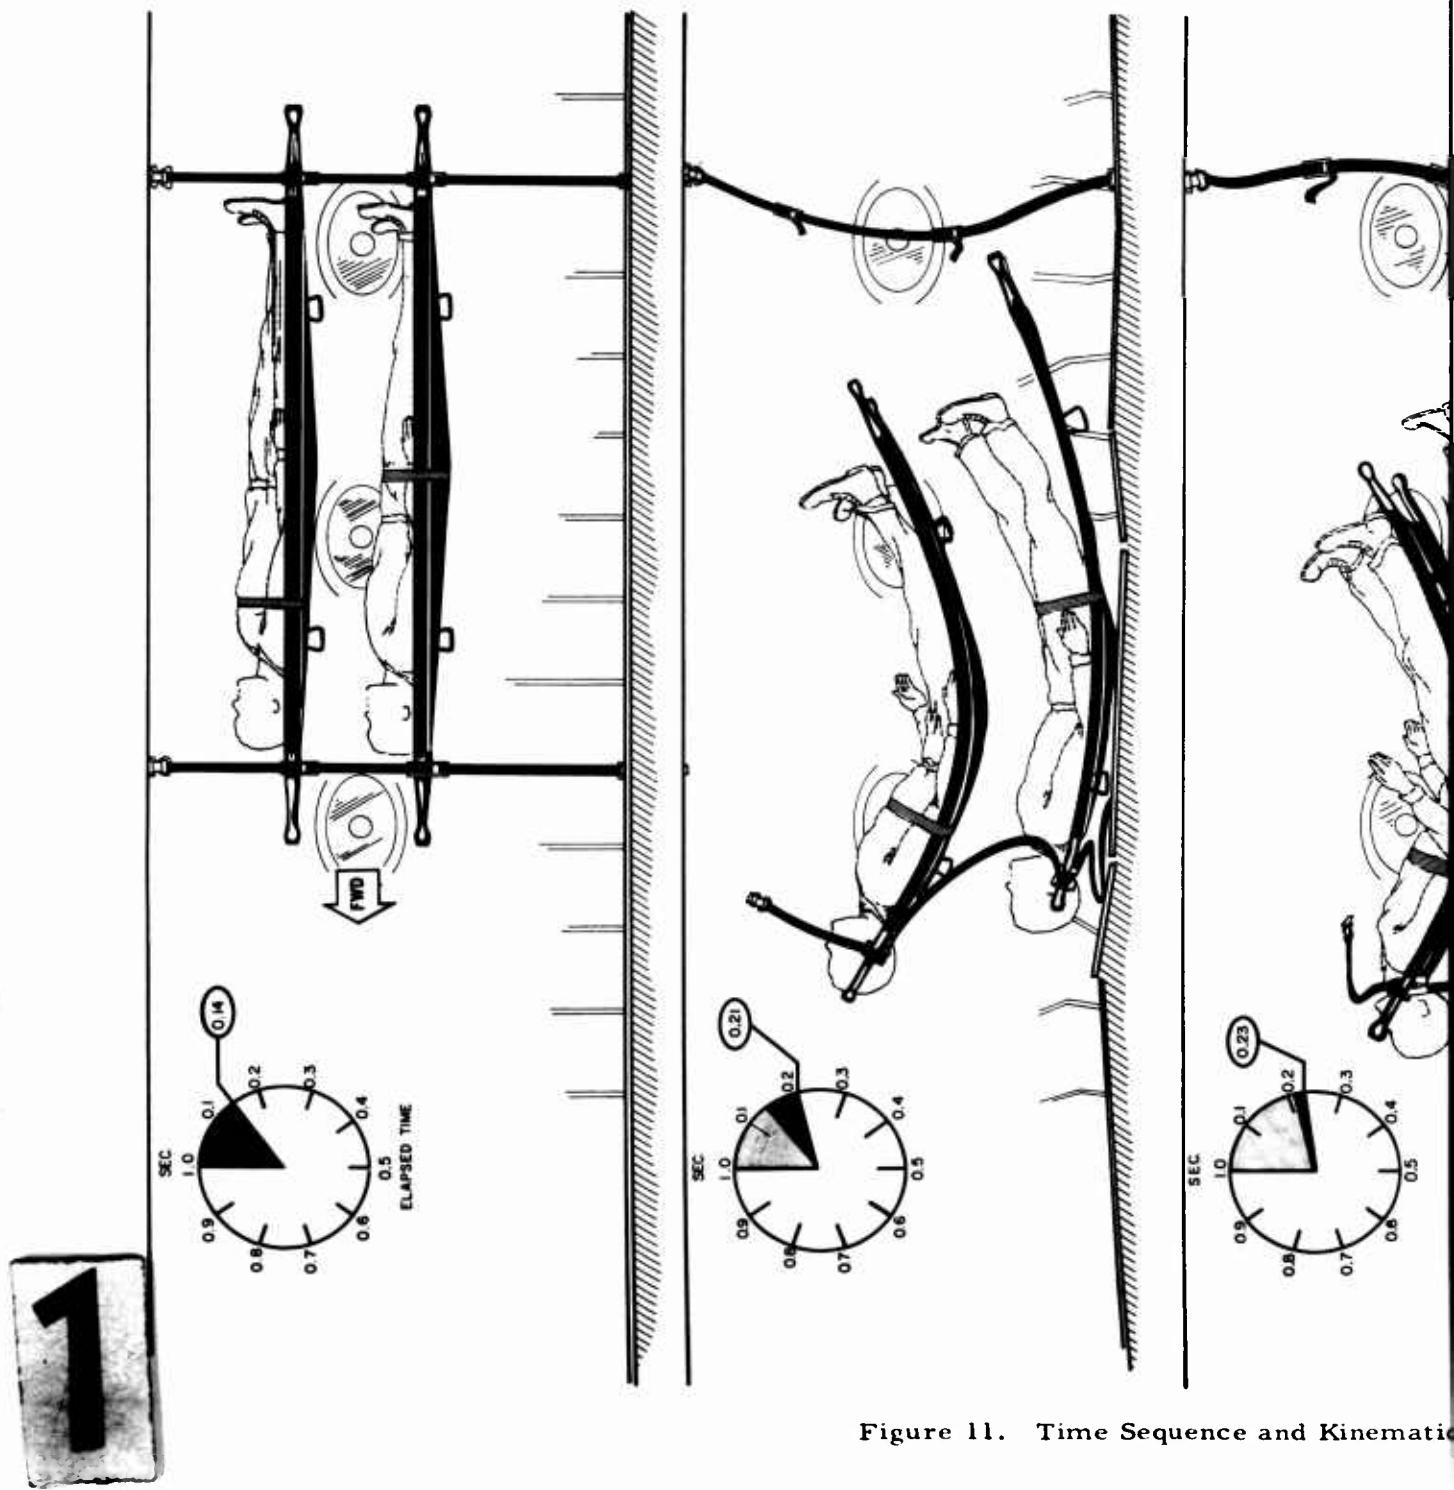
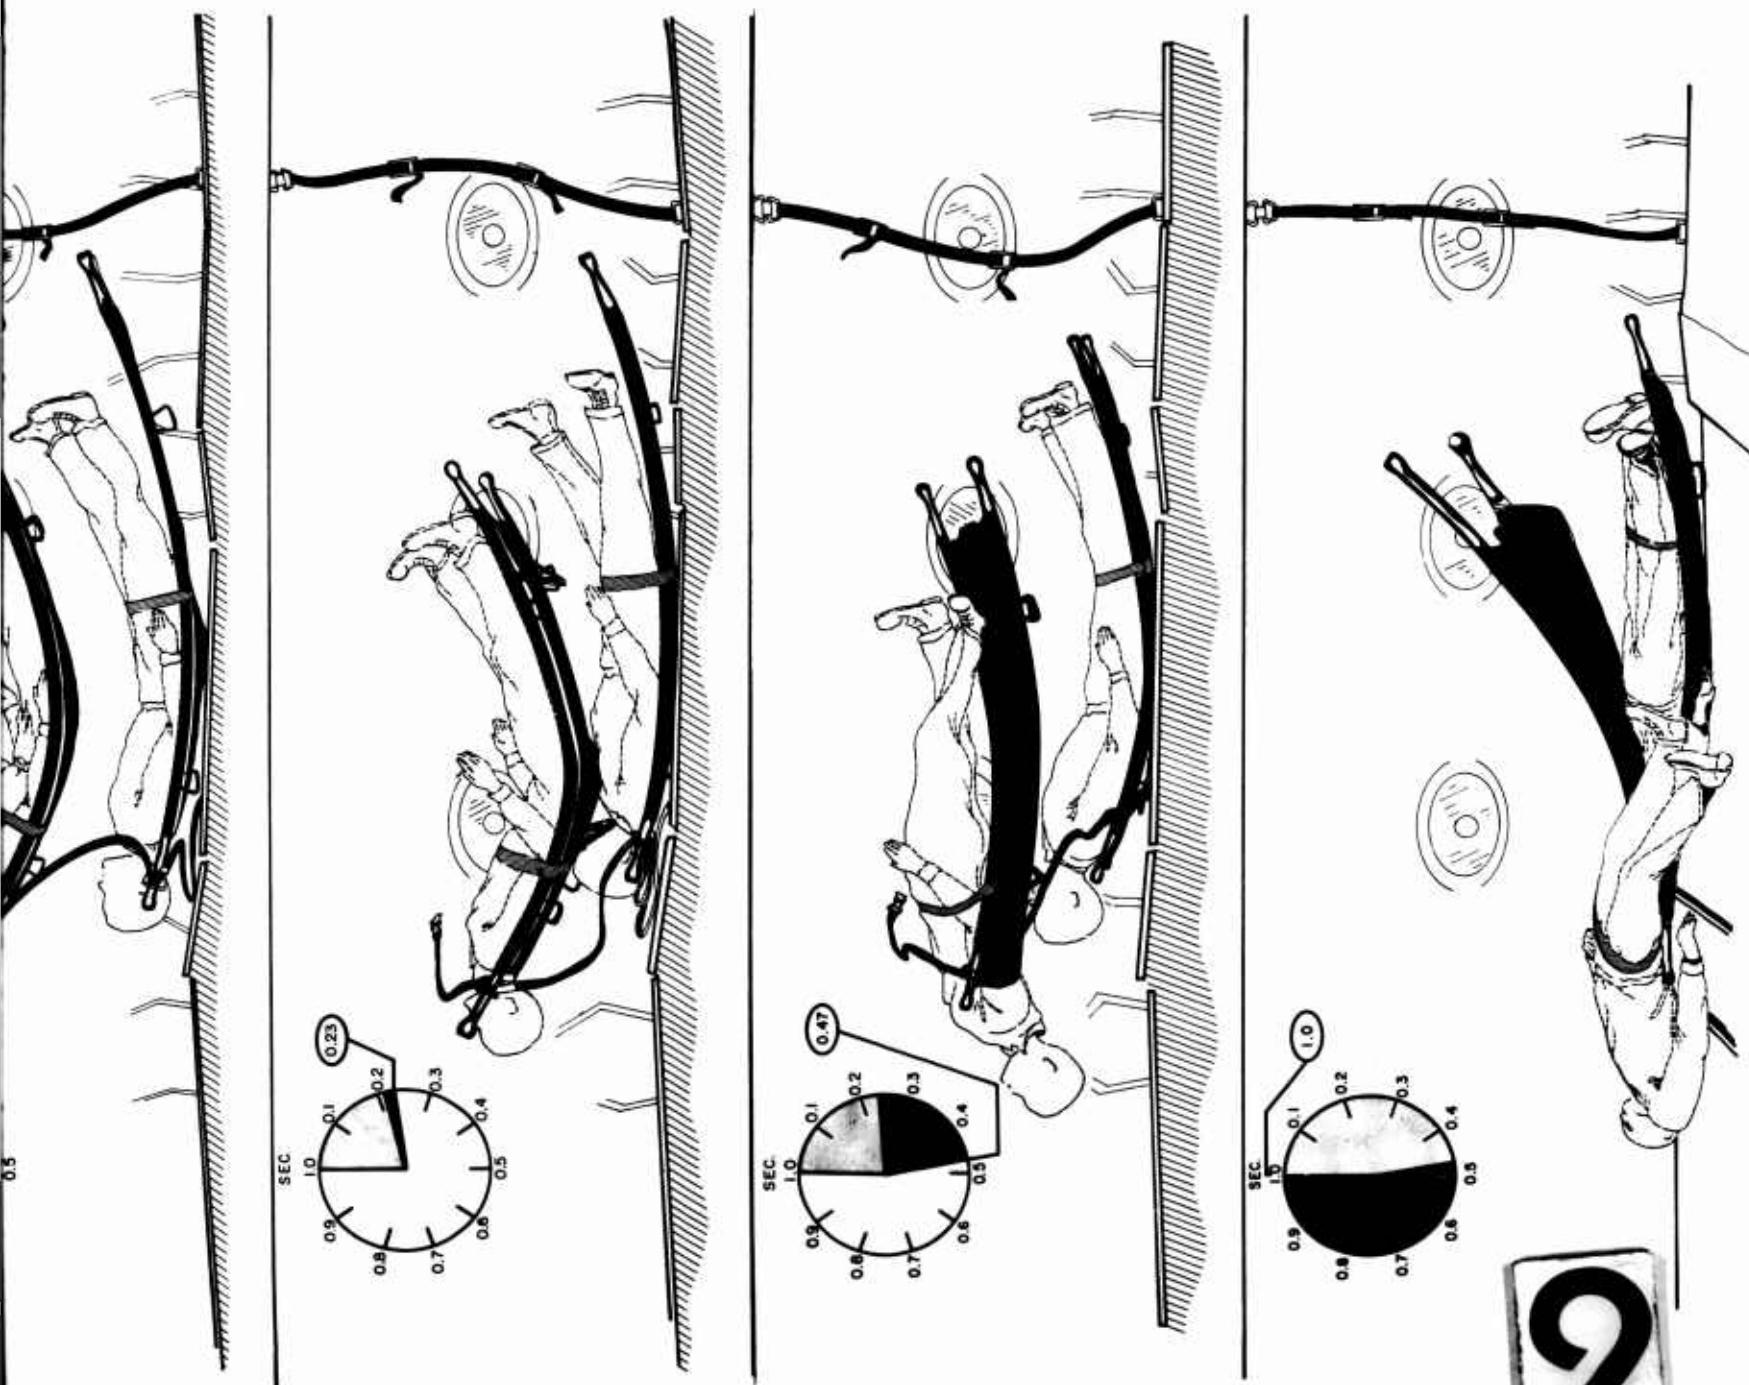
Figure 11. Time Sequence and Kinematics of Litter Failures.

During the impact sequence, the forward litter strap attachment-fitting ripped out of the overhead structural member. At the same time all four of the sidewall litter attachment brackets ripped off the structural members resulting in both litters, with the "patients" becoming projectiles, crashing to the floor, one atop the other.

The data obtained from this test will form a basis for a report designating the required modification or revision of the litter specification. Figure 11 depicts the time sequence and kinematics of the litter installation during the crash.

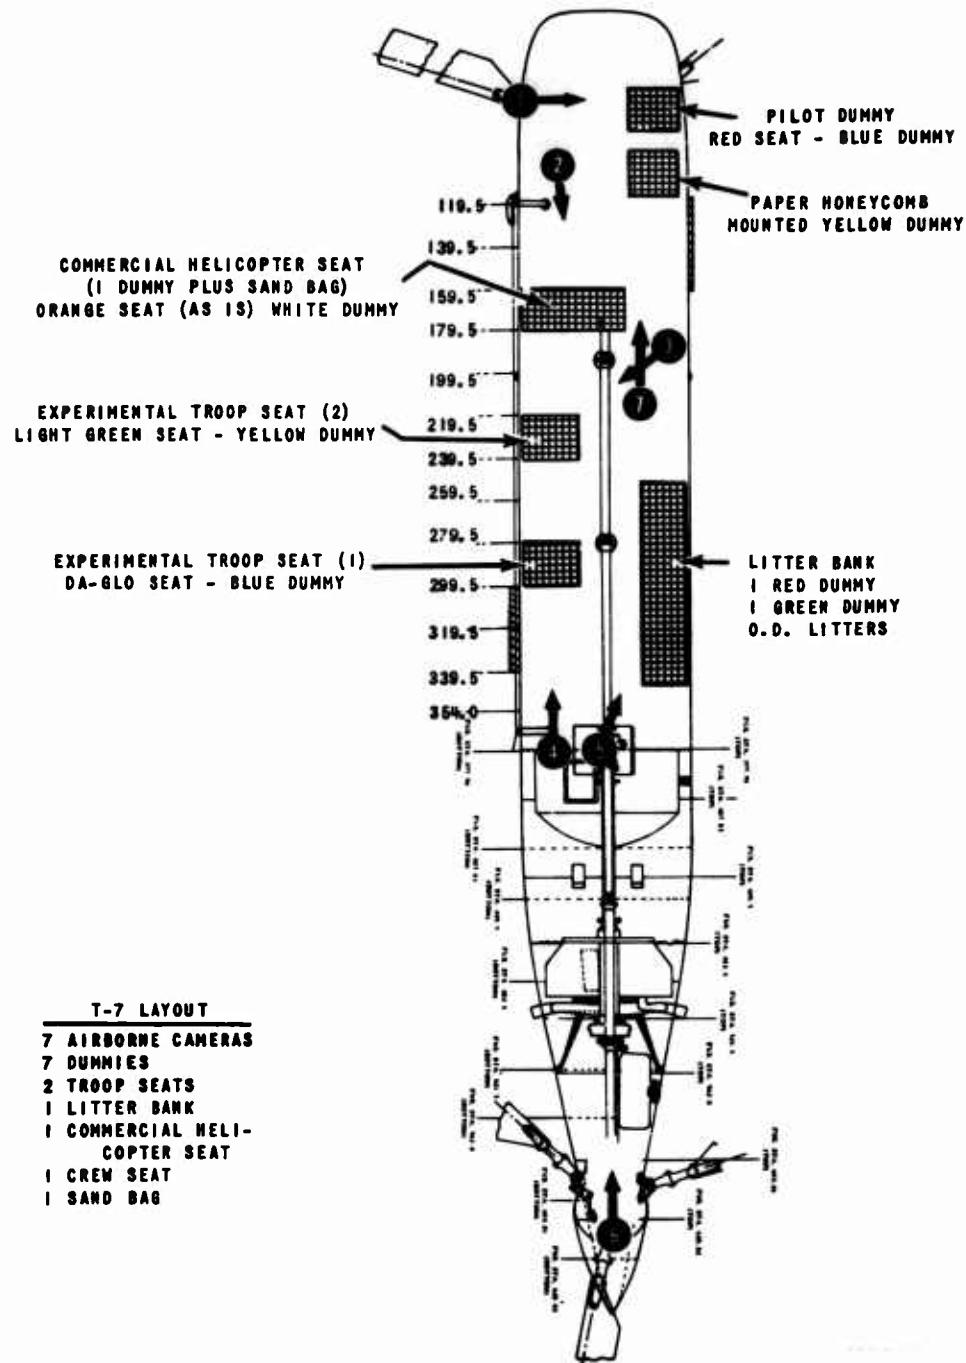
Figure 16. Schematic Diagram of Aircraft and Various Installations.

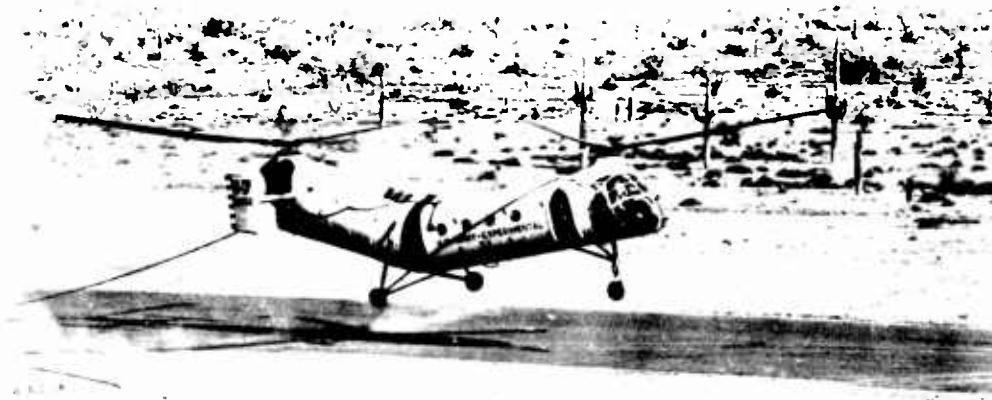
Figure 18. Crash Test Vehicle Just After Lift-Off.
Note trailing umbilical cable through which all data were recorded during actual crash sequence.

Figure 19. Crash Test Vehicle During Flight Under Complete Remote Control.

Figure 20. Aircraft Just After Impact.
The nose gear and both main gears have completely failed.
Note the wrinkles in the fuselage skin in the dark band just ahead of the main landing gear.

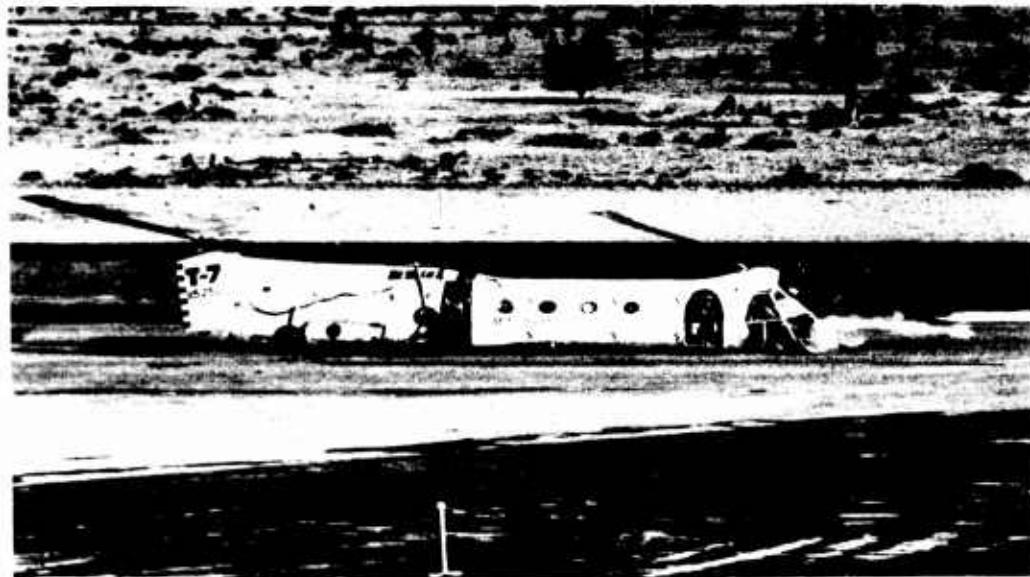
Figure 21. Entire Bottom Surface of Fuselage Is in Contact With the Ground.

Figure 22. Aircraft Turning and Tail Moving Upward Again to Its Normal Position.

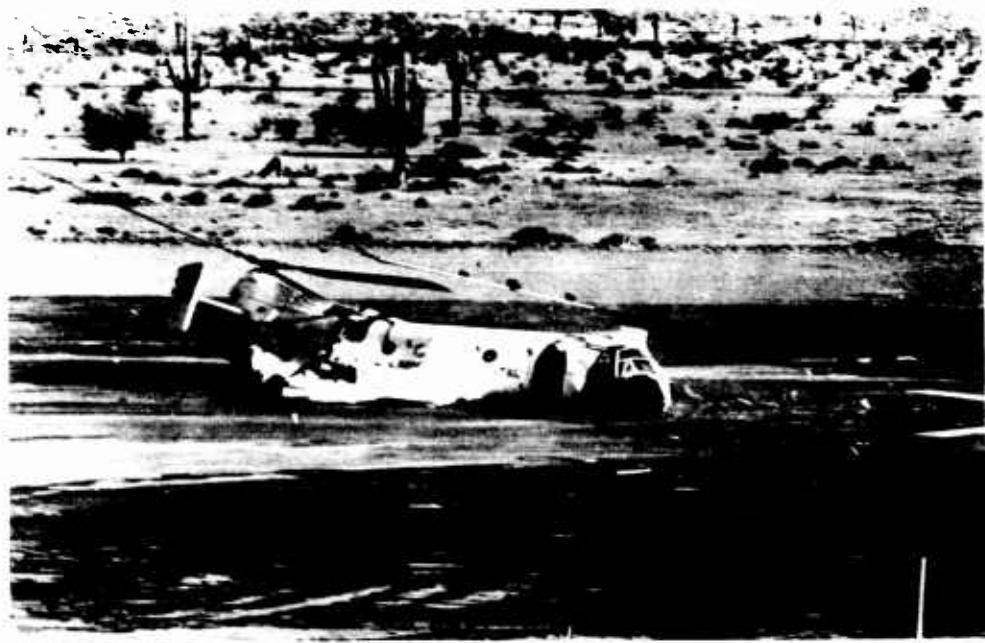
ignited and burned for approximately 2 minutes. Very little damage was done by the fire before it died down and was subsequently extinguished. Exact cause of the fire is not known at this time; however, preliminary examination of the high-speed film has led us to assume that abraded sparks from the main gear attach points caused the ignition. All elements of the crash fire inerting system functioned except the electrical cutoff system. It is also possible that failure of this part of the system may have resulted in sparks which could have ignited the fire.

Figure 23. Photograph Taken Shortly After the Flash Fire Began.
(The aircraft now beginning to rotate clockwise.)

Figure 24. Tail Section and Its Relationship to the Forward Portion of the Fuselage.
